**SOILS AND FOUNDATION  
REPORT NO. 06-08**

**PROJECT PRA-BLRI 2P16  
WALL SLIDE REPAIR, MP 364.72**

**BLUE RIDGE PARKWAY  
BUNCOMBE COUNTY, NORTH CAROLINA**

**June 2008**

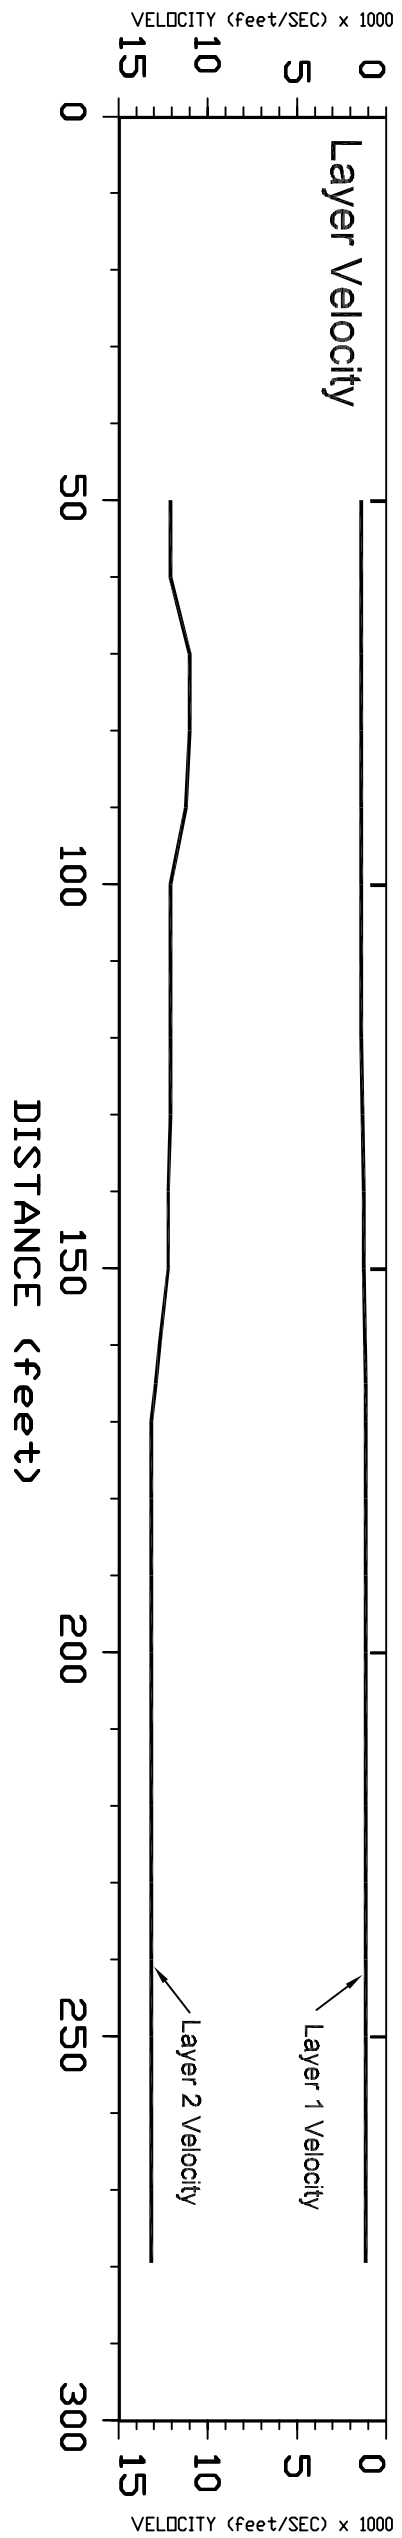
Figure: 1

Scale: H25' - V20'

It should be noted that the quality of the data is fair which made it difficult to pick the first arrivals. In addition, it appears that on some of the records, a high velocity surface layer exists, further complicating the interpretation of the data. This layer may represent the hard surface layer along a road. Since the data was recorded in a valley it is not certain that the first refractor is underneath the seismic spread or to one side of the spread and it may come from a dipping layer. In this case the depths are those orthogonal to the refractor dip and are not vertical depths to the refractor beneath the spread.

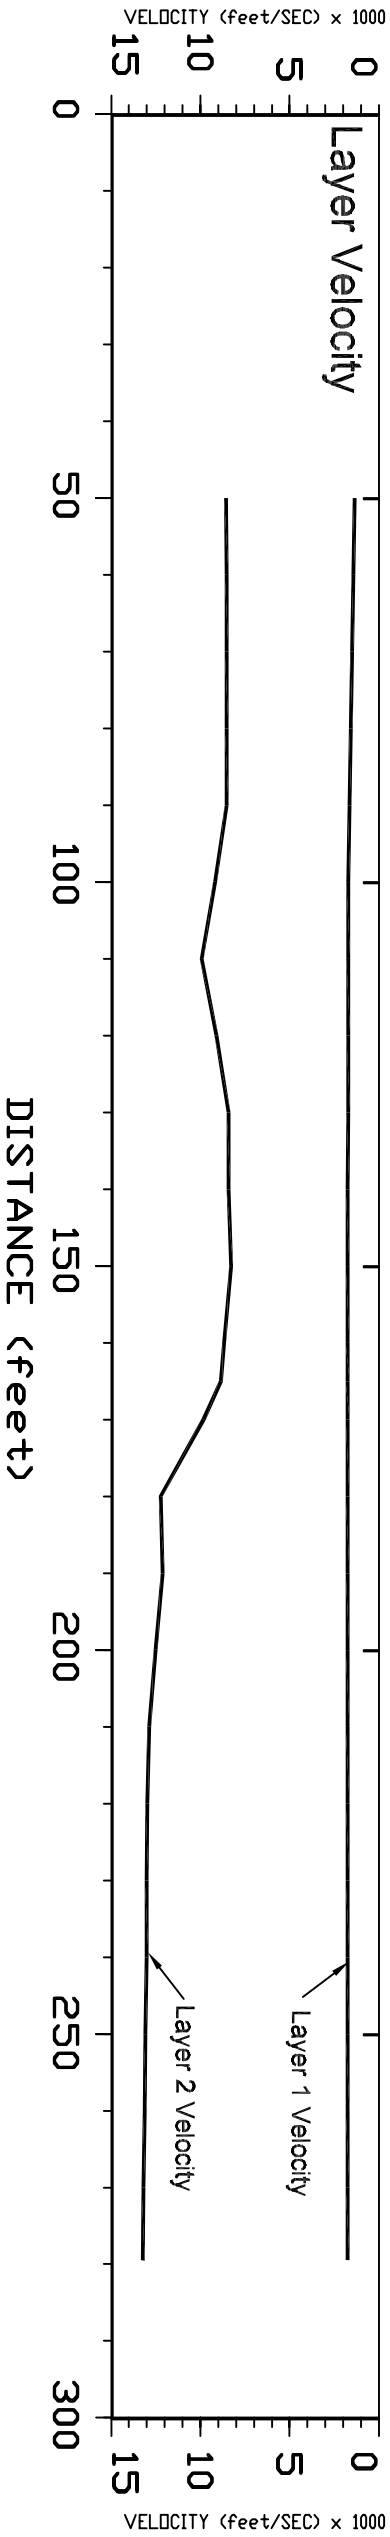
Each seismic refraction line is shown as a separate figure. Line 0001 is shown on Figure 1, while Line 001 is shown on Figure 2. Each figure contains three GRM plot windows with the tomography results displayed on the middle GRM window. The upper window shows the first break pick data with layer fits. The middle window shows the cross sectional profile of the GRM solution. The lower window shows the GRM solution layer P-wave velocities.

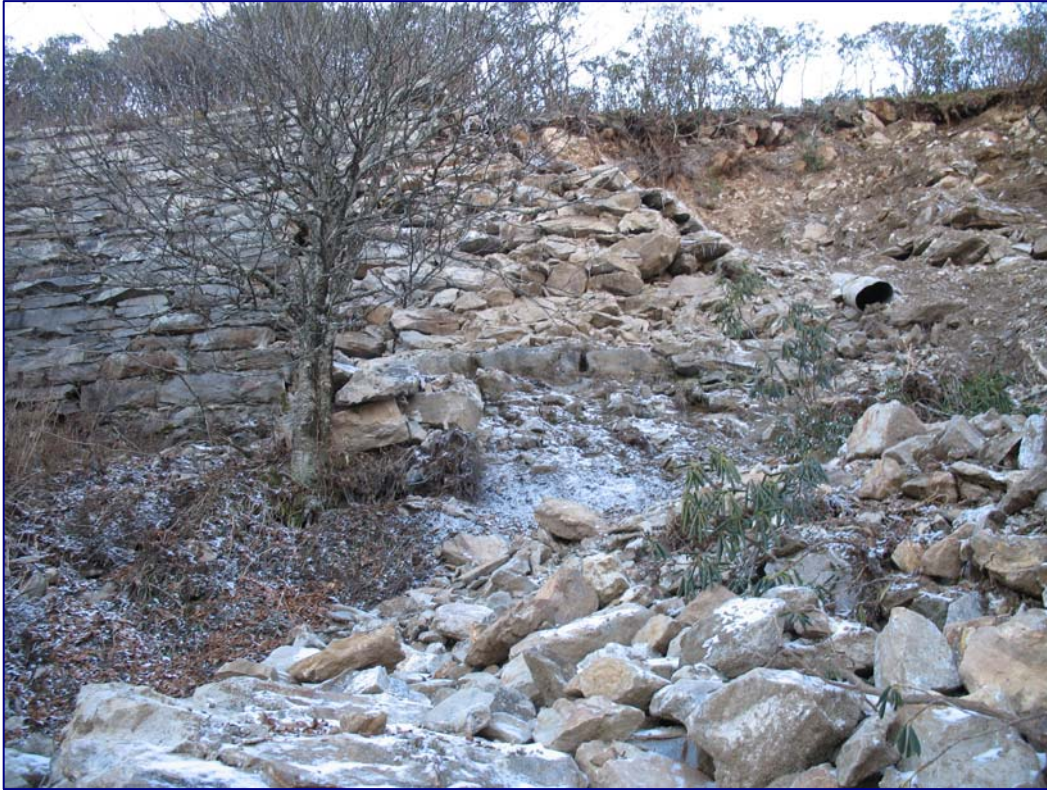
**Photo No. 1 - Collapsed Wall Section Around CMP Pipe Culvert**

Project BLRI 2P16 is located in the Asheville District of the Blue Ridge Parkway. A recent collapse of a mortared stone retaining wall occurred at the above-referenced location. The wall slide is centered around an 18-inch diameter pipe culvert that has an outlet at the face of the wall. The collapsed section of the wall is approximately 54 ft long with a vertical scarp located at approximately 15 feet behind the collapsed wall backface. A vertical slide scarp is located at approximate distance of 13-ft beyond the back of the guardrail at the time of field investigations. The height of the wall at the collapsed section is estimated between 25 ft and 30 ft. The retaining wall supports a portion of the Blue Ridge Parkway embankment leading to Craggy Pinnacle Tunnel and Craggy Gardens Visitor Center and supports a 2-lane asphalt concrete (AC) paved road.

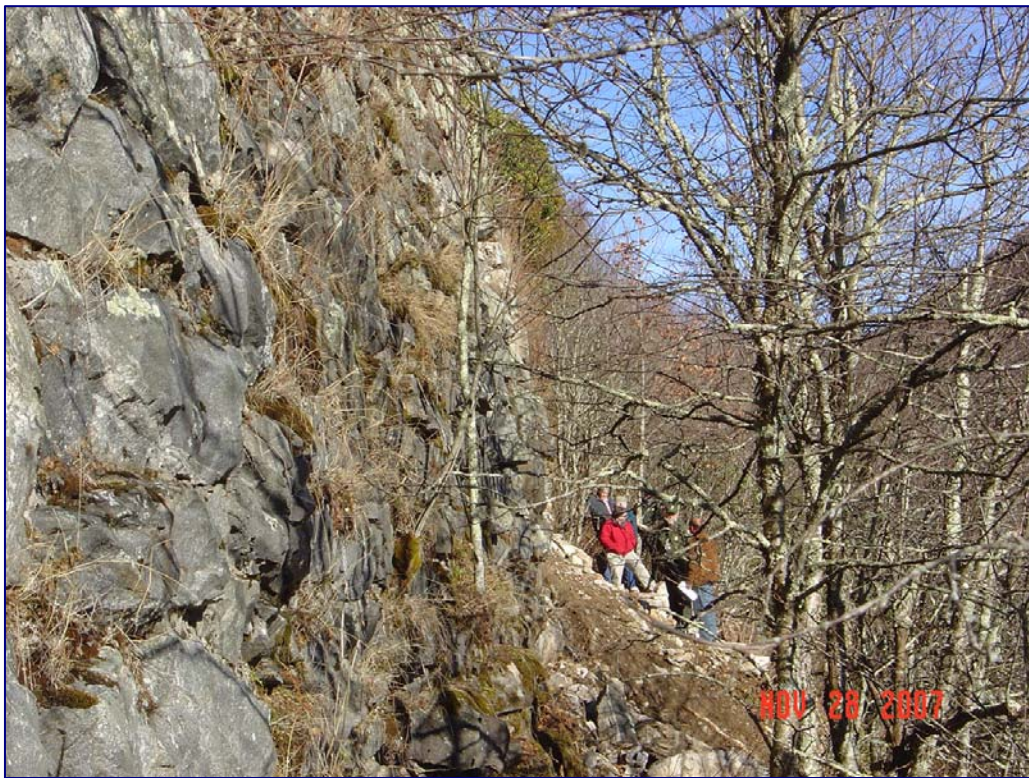
**Photo No. 2 – Southern Bulging Wall Section**

In addition to the collapsed section of the wall, there are signs that the adjacent sections of the wall are facing eminent failure. Shearing and bulging of the mortared stone facing was observed at these locations. The stone wall facing located immediately to the south of the collapse area has separated from the rock fill wall portion. Field measurements indicated that these adjacent sections extend a distance of 26 ft from the northern end of the collapsed wall and 28 ft from the southern end of the collapsed wall sections. The exposed backfill material behind the existing wall was observed to consist of silty sand soils and shot rock.

As mentioned earlier, the wall sections located immediately to the north and south of the failed wall exhibited signs of distress and bulging. Portions of the bulging wall sections may have to be reconstructed in order to properly achieve vertical and horizontal alignment. The remaining sections can be stabilized by installing rock anchors with steel plate anchor heads. A schematic diagram of the proposed anchor stabilization system is shown in Figure 6.

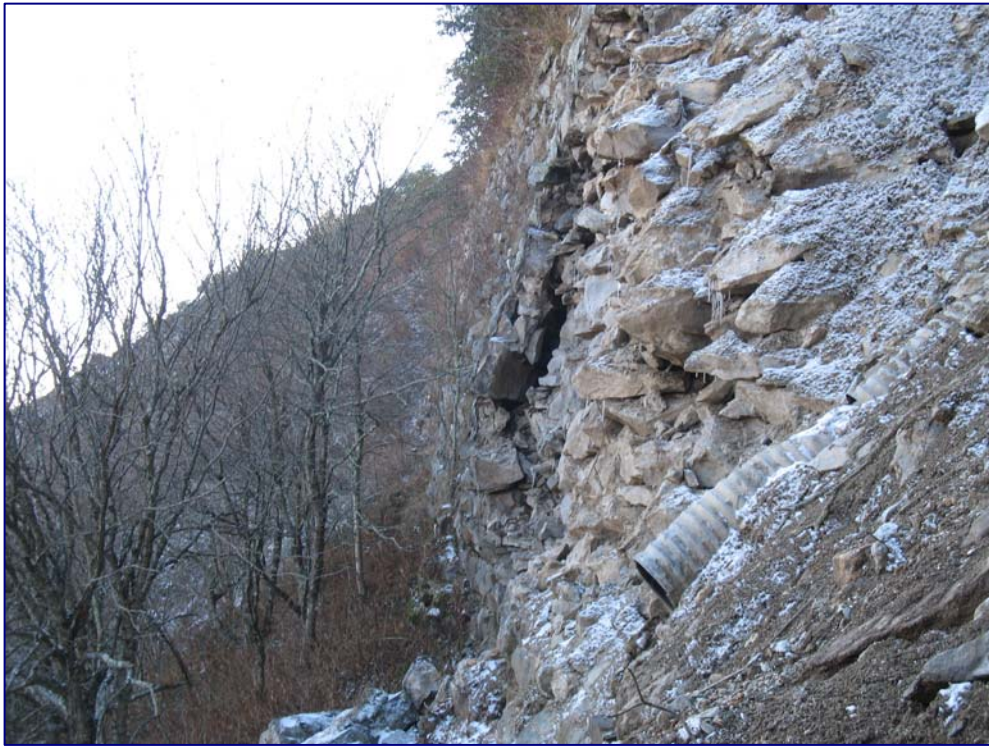
**Photo No. 3 – Looking South, Mortared Wall Face and Rockfill**

field investigations, a 600± ft stone wall is located at the toe of the fill for the roadway embankment. The wall appears to consist of 4 to 6 ft wide shot rock and a mortared stone facing that was constructed against the shot rock. The thickness of the mortared stone face wall varies from 18 to 24 inches. The stone facing is constructed at a slight batter. The wall varies in height from 20 to 30 ft.

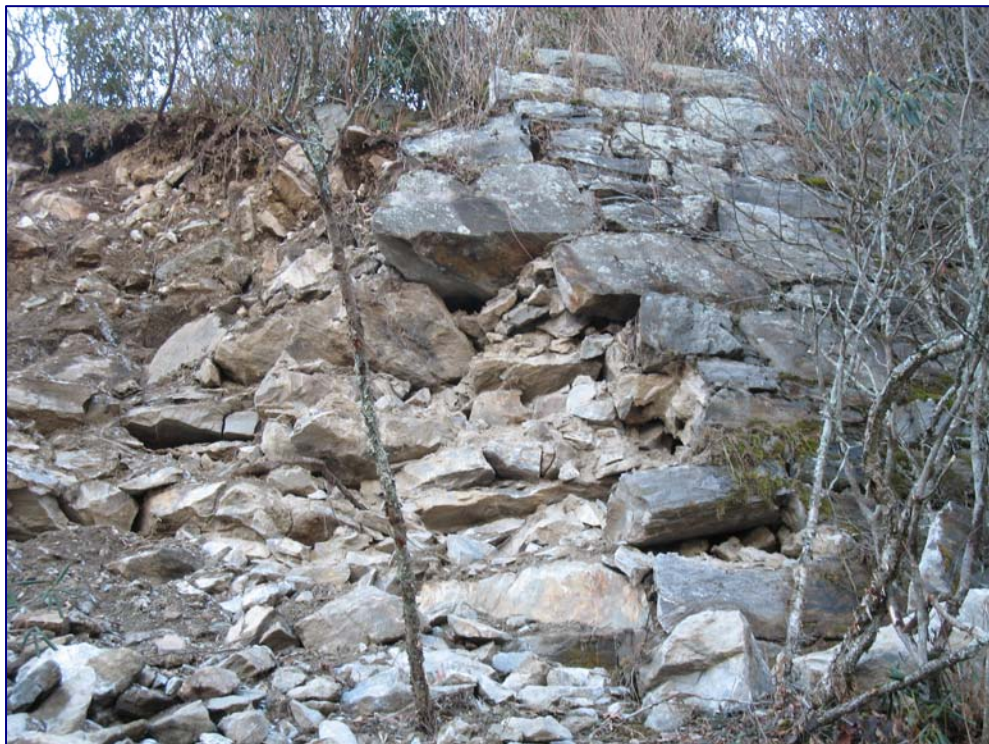
**Photo No. 4 – Northern End of Wall Slide**
